**Flood Control Project Maintenance
Levee Inspections**
LMA District Cover Sheet
Spring 2019 Levee Inspection Results

American River Flood Control District

Spring 2019 Levee Inspection Results

Waterway			Bank	Unit Miles
Unit No. 01 Arcade Creek			Left	2.08
	Spring (March - May)	Summer (June - August)	(September - November) Fall	Winter (December - February)
Unit Maintenance Rating (Fall Only)				
Date of Inspection	5/14/2019 - 5/14/2019			
DWR Inspector	Luz Dial			
Accompanied By	Ross Kawamura ARFCD

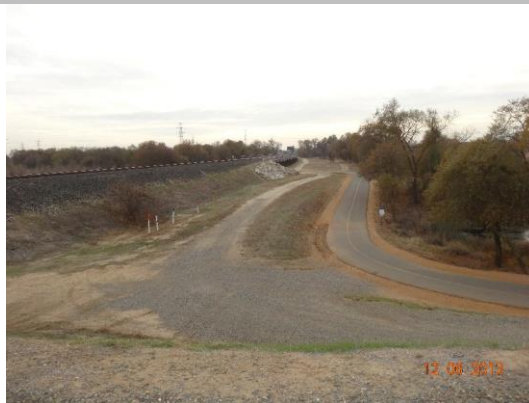
Photo 3 of 3 : UCIP_SP_2019_29826_55133.jpg

LM Start	1.91	Rating **	M	Issue No.	31 (cont)	
LM End	1.91	Issue Type +	En	Location *		
Category	Supplemental			GPS Latitude/Longitude		
				Start	End	
Item	DWR UCIP Field Study			38.596108 °	38.596108 °	
				-121.449887 °	-121.449887 °	
DWR ID	24294					
Comment Code						
Inspector Comment						
FS_ID:29826						
DS_ID:24294						
EP_NO: N/A						
Repair Type: Non-Urgent						
Crossing Status: Indicator Found						
UCIP Comments: Unable to confirm the diameter size or which owner is responsible for crossing. Owner could be Quest Communication or MCI--Need to contact owner to confirm crossing and obtain encroachment permit for work.						
FIELD_STRUCT_DESC: Communications conduit through the levee at unknown depth. [Additional Reference(s): DWR Levee Log, 2002]						
FS Date: 12/6/2013

View of waterward side--markers visible.

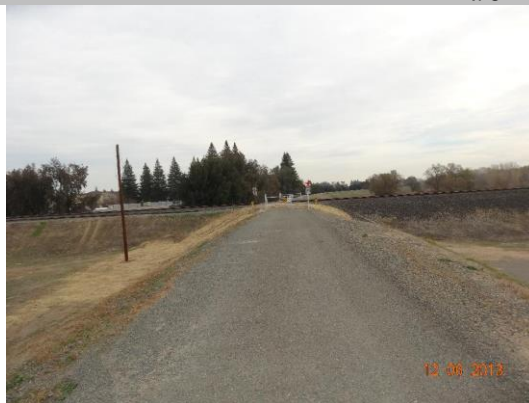
Photo 1 of 3 : UCIP_SP_2019_29827_55141.jpg

LM Start	1.92	Rating **	M	Issue No.	32
LM End	1.92	Issue Type +	En	Location *	
Category	Supplemental			GPS Latitude/Longitude	
				Start	End
Item	DWR UCIP Field Study			38.596108 °	38.596108 °
				-121.449887 °	-121.449887 °
DWR ID	24296				
Comment Code					
Inspector Comment					
FS_ID:29827					
DS_ID:24296					
EP_NO: N/A					
Repair Type: Non-Urgent					
Crossing Status: Indicator Found					
UCIP Comments: Unable to confirm the diameter size or which owner is responsible for crossing. Owner could be Quest Communication or MCI--Need to contact owner to confirm crossing and obtain encroachment permit for work.					
FIELD_STRUCT_DESC: 3-inch cable through the levee, 2.5 feet below the crown. Two overhead telephone lines across the levee at location.					
[Additional Reference(s): DWR Levee Log, 2002]					
FS Date: 12/6/2013

Overview of levee crown looking upstream at crossing.

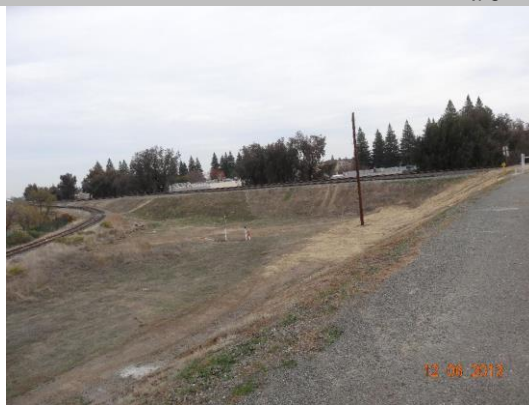
Photo 2 of 3 : UCIP_SP_2019_29827_55140.jpg

Conduit markers visible on landward side.

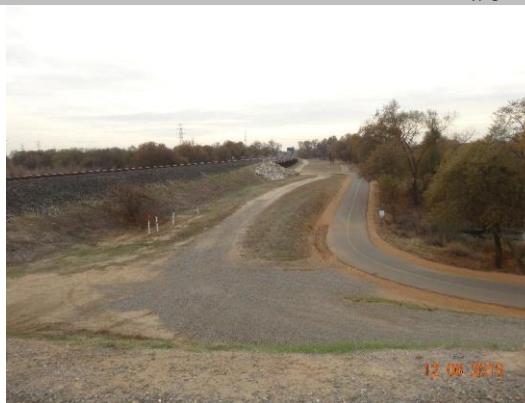
Photo 3 of 3 : UCIP_SP_2019_29827_55139.jpg

LM Start	1.92	Rating **	M	Issue No.	32 (cont)	
LM End	1.92	Issue Type +	En	Location *		
Category	Supplemental			GPS Latitude/Longitude		
				Start	End	
Item	DWR UCIP Field Study			38.596108 °	38.596108 °	
				-121.449887 °	-121.449887 °	
DWR ID	24296					
Comment Code						
Inspector Comment						
FS_ID:29827 DS_ID:24296 EP_NO: N/A Repair Type: Non-Urgent Crossing Status: Indicator Found UCIP Comments: Unable to confirm the diameter size or which owner is responsible for crossing. Owner could be Quest Communication or MCI--Need to contact owner to confirm crossing and obtain encroachment permit for work. FIELD_STRUCT_DESC: 3-inch cable through the levee, 2.5 feet below the crown. Two overhead telephone lines across the levee at location. [Additional Reference(s): DWR Levee Log, 2002] FS Date: 12/6/2013

Conduit markers visible on waterward side.

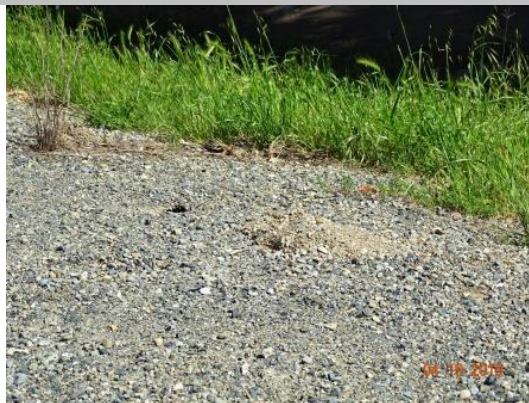
Photo 1 of 1 : SP_2019_NA0001_490_13_20190422_00031.jpg

LM Start	3.15	Rating **	A/W	Issue No.	13
LM End	3.15	Issue Type +	Ma	Location *	LS
Category	Earthen Levee			GPS Latitude/Longitude	
				Start	End
Item	Animal Control			38.599025 °	38.599025 °
				-121.470028 °	-121.470028 °
DWR ID	DWR_NA0001_03_s_2019_13				
Comment Code					
A3 : No rodents visible, but rodent burrows visible; need to backfill and compact or grout burrows.					
Inspector Comment					
Monitor animal activity.

View of animal holes on levee slope. Spring 2019

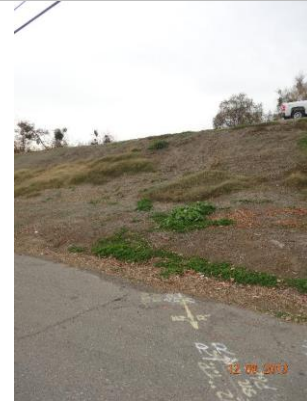
Photo 1 of 3 : UCIP_SP_2019_52686_53391.jpg

Comment Code					
Inspector Comment					
FS_ID:52686 DS_ID:24648 EP_NO: 911 Repair Type: Non-Urgent Crossing Status: Found UCIP Comments: 08/11/2017 PG&E records for DFM 0613-01 indicate that there were no observations found on the 07/2017 patrol, no leaks found on the 05/2017 leak survey, and the pipeline is operating correctly according to the 04/2017 CP inspection. ECDA in 2015; this integrity assessment identified no issues requiring corrective action. ILI in 2016; all corrective actions identified in this integrity assessment have been resolved. (DWR UCIP - A. McDonald)8/11/2016 Markers found on WS. No markers found on LS. Crossing has been downgraded from Urgent to Non-Urgent, pipe has been marked on WS only. (DWR UCIP - omagana)2/6/2015 Permit information was entered and crossing description updated. (DWR UCIP - omagana)12/3/13 Need to contact owner to determine status of crossing. Markers missing. (DWR UCIP - omagana) FIELD_STRUCT_DESC: 12.75-inch gas line of unknown material through the levee at unknown depth. Markers found on the waterside (WS) approximately 192 feet and 410 feet from levee crown. No markers found on landside (LS). In case of an emergency related to this pipeline, PG&E has identified the following contacts: PG&E's local pipeline engineer, Mike Aronoff at 916-307-9472 (cell), and Gas Control (north) at 800-442-4743. For non-emergency issues, please contact the local PG&E Gas Pipeline Operations and Maintenance (GPOM) supervisors for the Sacramento region, David Wade at 209-639-1039 (cell), or Ron Hicks at 916-396-9038 (cell). (12.75-inch line installed under Permit No. 911, 1943 - Pacific Gas and Electric Company [PG&E]) FS Date: 8/11/2016

View of LS slope and USA paint markings indicating alignment.

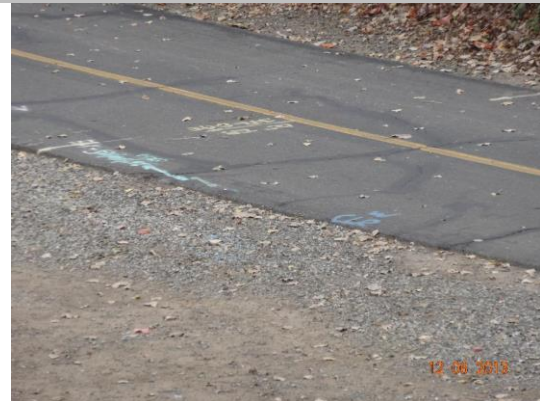
Photo 2 of 3 : UCIP_SP_2019_52686_53390.jpg

Comment Code						
Inspector Comment						
FS_ID:52686 DS_ID:24648 EP_NO: 911 Repair Type: Non-Urgent Crossing Status: Found UCIP Comments: 08/11/2017 PG&E records for DFM 0613-01 indicate that there were no observations found on the 07/2017 patrol, no leaks found on the 05/2017 leak survey, and the pipeline is operating correctly according to the 04/2017 CP inspection. ECDA in 2015; this integrity assessment identified no issues requiring corrective action. ILI in 2016; all corrective actions identified in this integrity assessment have been resolved. (DWR UCIP - A. McDonald)8/11/2016 Markers found on WS. No markers found on LS. Crossing has been downgraded from Urgent to Non-Urgent, pipe has been marked on WS only. (DWR UCIP - omagana)2/6/2015 Permit information was entered and crossing description updated. (DWR UCIP - omagana)12/3/13 Need to contact owner to determine status of crossing. Markers missing. (DWR UCIP - omagana) FIELD_STRUCT_DESC: 12.75-inch gas line of unknown material through the levee at unknown depth. Markers found on the waterside (WS) approximately 192 feet and 410 feet from levee crown. No markers found on landside (LS). In case of an emergency related to this pipeline, PG&E has identified the following contacts: PG&E's local pipeline engineer, Mike Aronoff at 916-307-9472 (cell), and Gas Control (north) at 800-442-4743. For non-emergency issues, please contact the local PG&E Gas Pipeline Operations and Maintenance (GPOM) supervisors for the Sacramento region, David Wade at 209-639-1039 (cell), or Ron Hicks at 916-396-9038 (cell). (12.75-inch line installed under Permit No. 911, 1943 - Pacific Gas and Electric Company [PG&E]) FS Date: 8/11/2016

Underground service alert (USA) approximate alignment for 12-inch gas line through levee and WS--USA markings on bike path.

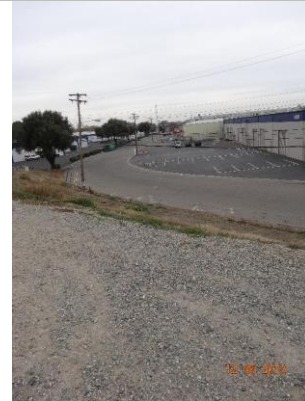
Photo 3 of 3 : UCIP_SP_2019_52686_53389.jpg

Comment Code						
Inspector Comment						
FS_ID:52686 DS_ID:24648 EP_NO: 911 Repair Type: Non-Urgent Crossing Status: Found UCIP Comments: 08/11/2017 PG&E records for DFM 0613-01 indicate that there were no observations found on the 07/2017 patrol, no leaks found on the 05/2017 leak survey, and the pipeline is operating correctly according to the 04/2017 CP inspection. ECDA in 2015; this integrity assessment identified no issues requiring corrective action. ILI in 2016; all corrective actions identified in this integrity assessment have been resolved. (DWR UCIP - A. McDonald)8/11/2016 Markers found on WS. No markers found on LS. Crossing has been downgraded from Urgent to Non-Urgent, pipe has been marked on WS only. (DWR UCIP - omagana)2/6/2015 Permit information was entered and crossing description updated. (DWR UCIP - omagana)12/3/13 Need to contact owner to determine status of crossing. Markers missing. (DWR UCIP - omagana) FIELD_STRUCT_DESC: 12.75-inch gas line of unknown material through the levee at unknown depth. Markers found on the waterside (WS) approximately 192 feet and 410 feet from levee crown. No markers found on landside (LS). In case of an emergency related to this pipeline, PG&E has identified the following contacts: PG&E's local pipeline engineer, Mike Aronoff at 916-307-9472 (cell), and Gas Control (north) at 800-442-4743. For non-emergency issues, please contact the local PG&E Gas Pipeline Operations and Maintenance (GPOM) supervisors for the Sacramento region, David Wade at 209-639-1039 (cell), or Ron Hicks at 916-396-9038 (cell). (12.75-inch line installed under Permit No. 911, 1943 - Pacific Gas and Electric Company [PG&E]) FS Date: 8/11/2016

View of LS with undergroundservice alert (USA) paint with approximate alignment of multiple crossing in general area.

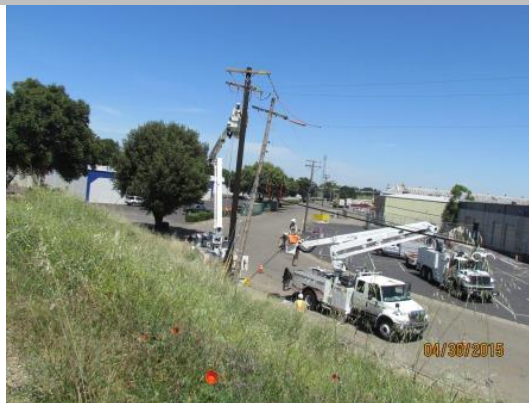
Photo 1 of 1 : SP_2019_NA0001_490_24_20190307_00001.jpg

LM Start	3.31	Rating **	M	Issue No.	24
LM End	3.31	Issue Type +	En	Location *	LS
Category	Earthen Levee			GPS Latitude/Longitude	
				Start	End
Item	Encroachments			38.600958 °	38.600958 °
				-121.471618 °	-121.471618 °
DWR ID	DWR_NA0001_03_s_2015_24				
Comment Code					
PO : Pole					
Inspector Comment					
SMUD replacing old pole at the landside toe of the levee. Pole line does not appear to be permitted, but it might be part of the levee log entry 179 LM3.17.

View of a new pole installed at the landside levee toe. Spring 2015

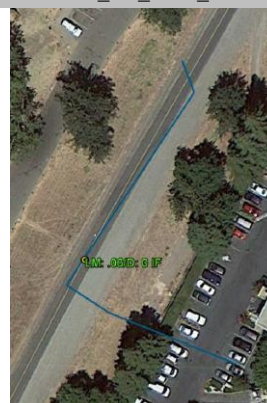
Photo 1 of 3 : UCIP_SP_2019_29003_53405.jpg

LM Start	0.06	Rating **	M	Issue No.	746
LM End	0.06	Issue Type +	En	Location *	
Category	Supplemental			GPS Latitude/Longitude	
				Start	End
Item	DWR UCIP Field Study			38.597198 °	38.597198 °
				-121.506532 °	-121.506532 °
DWR ID	24344				
Comment Code					
Inspector Comment					
FS_ID:29003 DS_ID:24344 EP_NO: N/A Repair Type: Non-Urgent Crossing Status: Indicator Found UCIP Comments: Metal boxes located on landward side could be associated with utility -- unable to confirm. Will need to contact owner. FIELD_STRUCT_DESC: Electrical conduit of unknown material through the levee at unknown depth. FS Date: 12/19/2013

Approximate alignment provided by the City of Sacramento for 2 inch line. Point labelled in green is field verified location where signs of crossing exist.

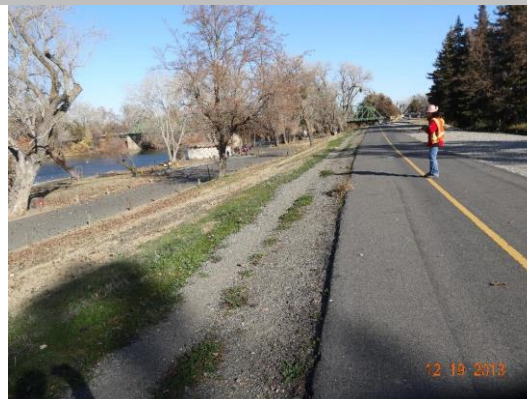
Photo 2 of 3 : UCIP_SP_2019_29003_53404.jpg

Overview of levee crown and waterward side.

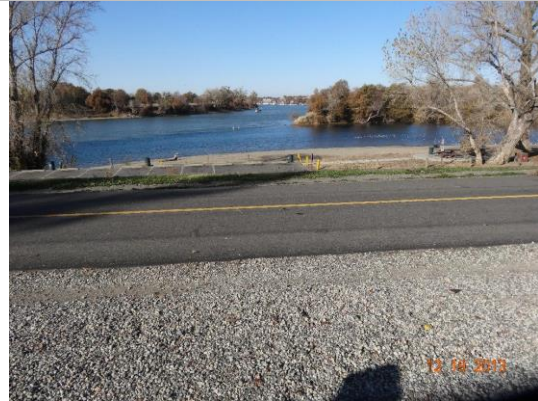
Photo 3 of 3 : UCIP_SP_2019_29003_53402.jpg

LM Start	0.06	Rating **	M	Issue No.	746 (cont)
LM End	0.06	Issue Type +	En	Location *	
Category	Supplemental			GPS Latitude/Longitude	
				Start	End
Item	DWR UCIP Field Study			38.597198 °	38.597198 °
				-121.506532 °	-121.506532 °
DWR ID	24344				
Comment Code					
Inspector Comment					
FS_ID:29003 DS_ID:24344 EP_NO: N/A Repair Type: Non-Urgent Crossing Status: Indicator Found UCIP Comments: Metal boxes located on landward side could be associated with utility -- unable to confirm. Will need to contact owner. FIELD_STRUCT_DESC: Electrical conduit of unknown material through the levee at unknown depth. FS Date: 12/19/2013

View of waterward side.

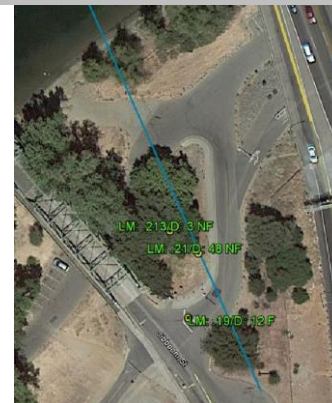
Photo 1 of 1 : UCIP_SP_2019_29006_53414.jpg

LM Start	0.21	Rating **	M	Issue No.	747
LM End	0.21	Issue Type +	En	Location *	
Category	Supplemental			GPS Latitude/Longitude	
				Start	End
Item	DWR UCIP Field Study			38.598982 °	38.598982 °
				-121.505045 °	-121.505045 °
DWR ID	24435				
Comment Code					
Inspector Comment					
FS_ID:29006 DS_ID:24435 EP_NO: 17171 Repair Type: Non-Urgent Crossing Status: Not Found UCIP Comments: Unable to find any indications that crossing is still active. Will need to contact owner to determine status of crossing. FIELD_STRUCT_DESC: 48-inch steel water line through the levee, approximately 32 feet below the crown. Siphon and blowoff valves in concrete riser on the landside (LS). (48-inch water transmission main authorized under Permit No. 17171, 2001-City of Sacramento, Department of Utilities) FS Date: 12/19/2013

Approximate alignment provided by the City of Sacramento--crossing not found during field visit.

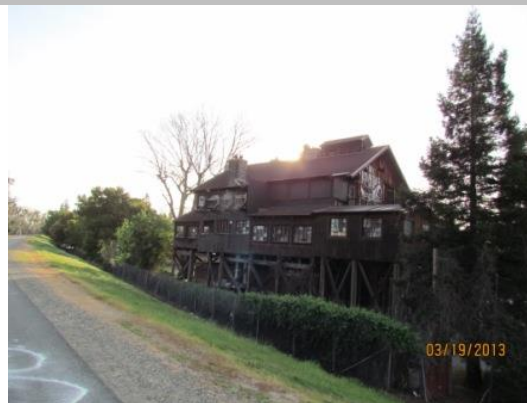
Photo 1 of 1 : SP_2019_NA0001_55_1_20190307_00001.jpg

LM Start	0.31	Rating **	M	Issue No.	1
LM End	0.45	Issue Type +	En	Location *	LS
Category	Earthen Levee			GPS Latitude/Longitude	
				Start	End
Item	Vegetation			38.599835 °	38.600769 °
				-121.503448 °	-121.501133 °
DWR ID	DWR_NA0001_04_s _ 2012_1				
Comment Code					
V6 : Landscaping					
Inspector Comment					
Vines and privacy fence within 10-ft of the landside toe or on the levee slope obstruct visibility and access.

View of the vines obstructing visibility.

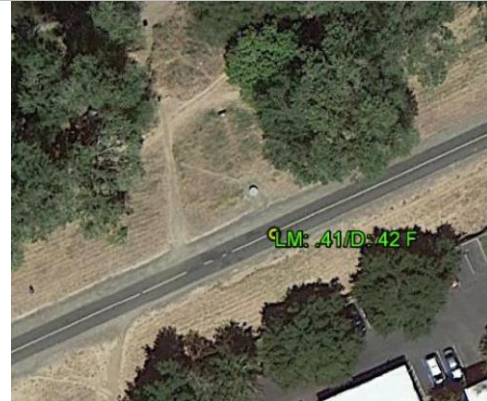
Photo 1 of 3 : UCIP_SP_2019_31249_57212.jpg

Comment Code						
Inspector Comment						
FS_ID:31249 DS_ID:24303 EP_NO: N/A Repair Type: Non-Urgent Crossing Status: Found UCIP Comments: 08/16/2017 DWR Deferred Maintenance Project (DMP), Vince Rodriguez, forwarded email received from Tim Kerr, General Manager of American River Flood Control District (ARFCD) with file "DWR Eligible Pipes Found in ARFCD" from ARFCD that shows the ownership and location of the pipes Tim Kerr investigated. No owner was identified, ARFCD Staff Notes indicate Abandoned (ARFCD/Bill) - No As-builts. (DWR UCIP - O. Magana) 12/19/2013 Non-functional crossing--need additional information about how crossing was abandoned. (DWR UCIP - O. Magana) FIELD_STRUCT_DESC: *ABANDONED* 42-inch corrugated metal drainage pipe through the levee, 16.5 feet below the crown. Gravel filled with both ends welded shut. Flap gate on the waterside (WS) end. Slide gate in corrugated metal riser and splash board drain structure on the landside (LS). (no permit has been identified authorizing this structure, no owner has been identified) [Additional Reference(s): DWR Levee Log, 2002. USACE Sacramento O&M Manual Unit 118 Part 1, August 1955, (Station 10+00)]. FS Date: 12/19/2013

Overview of crossing location.

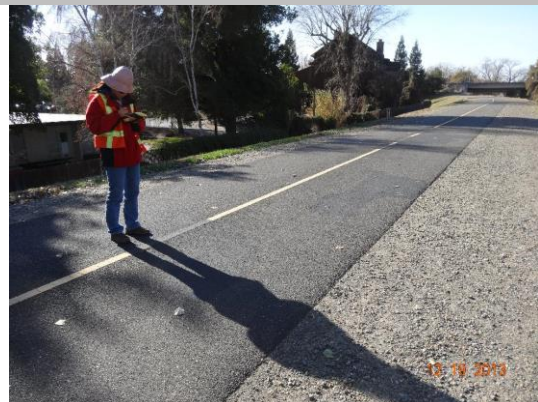
Photo 2 of 3 : UCIP_SP_2019_31249_57209.jpg

View of levee crown at this location.

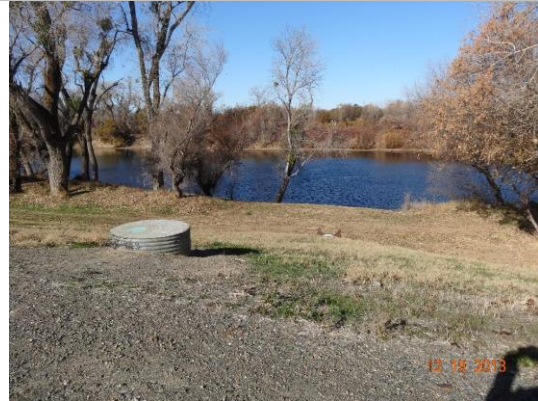
Photo 3 of 3 : UCIP_SP_2019_31249_57210.jpg

Comment Code						
Inspector Comment						
FS_ID:31249 DS_ID:24303 EP_NO: N/A Repair Type: Non-Urgent Crossing Status: Found UCIP Comments: 08/16/2017 DWR Deferred Maintenance Project (DMP), Vince Rodriguez, forwarded email received from Tim Kerr, General Manager of American River Flood Control District (ARFCD) with file "DWR Eligible Pipes Found in ARFCD" from ARFCD that shows the ownership and location of the pipes Tim Kerr investigated. No owner was identified, ARFCD Staff Notes indicate Abandoned (ARFCD/Bill) - No As-builts. (DWR UCIP - O. Magana) 12/19/2013 Non-functional crossing--need additional information about how crossing was abandoned. (DWR UCIP - O. Magana) FIELD_STRUCT_DESC: *ABANDONED* 42-inch corrugated metal drainage pipe through the levee, 16.5 feet below the crown. Gravel filled with both ends welded shut. Flap gate on the waterside (WS) end. Slide gate in corrugated metal riser and splash board drain structure on the landside (LS). (no permit has been identified authorizing this structure, no owner has been identified) [Additional Reference(s): DWR Levee Log, 2002. USACE Sacramento O&M Manual Unit 118 Part 1, August 1955, (Station 10+00)]. FS Date: 12/19/2013

View of waterward side--standpipe located on waterward slope. Standpipe filled with concrete.

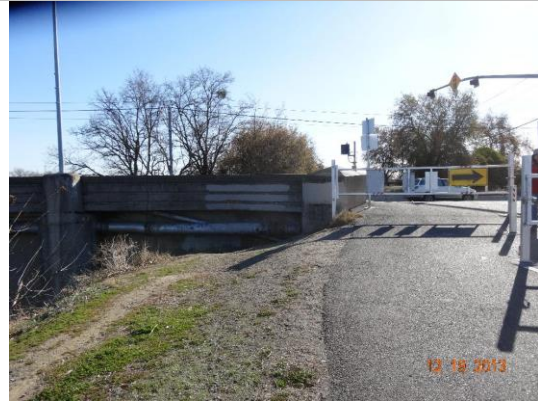
Photo 1 of 3 : UCIP_SP_2019_53602_53496.jpg

UCIP Comments: 07/18/2018 Besides the holes found in the sewer pipe, everything appears to be the same. Crossing remains "Urgent" due to the holes in the line. There could also be pipe integrity issues under the levee. Since this is an abandoned sewer line, recommend that this pipe be abandoned properly to eliminate any threats to the pipe or the levee. (DWR UCIP - A. McDonald)08/29/2017 After reviewing record dsid 24625, record dsid 24625 appears to be the same record as this entry, dsid 24307. The information from dsid 24625, has been transferred to this entry. The old record will be retired from the UCIP list and considered a duplicate record. This record has been updated to reflect record source origins from both DWR Levee Logs, referenced as a 20-inch pipe, and the USACE O&M manual, 18-inch pipe. (DWR UCIP - O. Magana)

8/11/2016 Crossing was classified incorrectly. Crossing is not a gas line. This crossing appears to be an abandoned sewer line. On WS, holes are present on the pipe wall and visible cracks are found on the concrete wall where pipe crosses. According to LMA, Tim Kerr and Richard Marck, this crossing could be a City line. Need to find owner and determine fate of crossing. Owner will need to coordinate with CVFPB to comply with Title 23. (DWR UCIP - omagana)12/19/2013 No markers or labels visible to indicate line is gas line--unable to confirm. (DWR UCIP - omagana)

FIELD_STRUCT_DESC: *ABANDONED* 18-inch (not 20-inch as referenced in the DWR Levee Log) wrapped steel sewer pipe through the levee, 5 feet below the crown. The 20-inch pipe was initially referenced as a 20-inch gas line under DWR levee logs that dated back to 1956. During the 2016 inspection, the pipe was identified (field measured) as an 18-inches non-gas line. The sewer pipe has holes in it. It appears that this crossing has been mislabeled or replaced. No additional information was found. This sewer pipe is not in use and needs to be abandoned properly or removed. [Additional Reference(s): DWR Levee Log, 1956 and 2002. USACE Sacramento O&M Manual Unit 118 Part 1, August 1955, (Station 89+28)].

View of line exposed at the bridge.

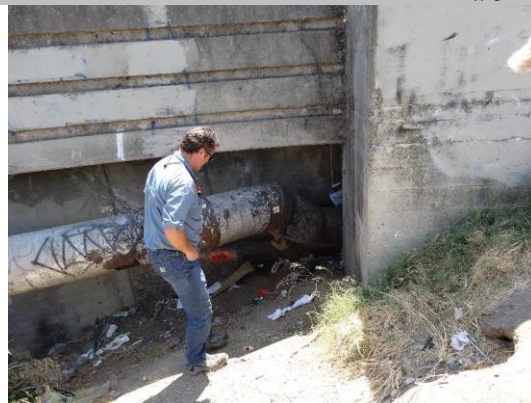
Photo 3 of 3 : UCIP_SP_2019_53602_75833.jpg

UCIP Comments: 07/18/2018 Besides the holes found in the sewer pipe, everything appears to be the same. Crossing remains "Urgent" due to the holes in the line. There could also be pipe integrity issues under the levee. Since this is an abandoned sewer line, recommend that this pipe be abandoned properly to eliminate any threats to the pipe or the levee. (DWR UCIP - A. McDonald)08/29/2017 After reviewing record dsid 24625, record dsid 24625 appears to be the same record as this entry, dsid 24307. The information from dsid 24625, has been transferred to this entry. The old record will be retired from the UCIP list and considered a duplicate record. This record has been updated to reflect record source origins from both DWR Levee Logs, referenced as a 20-inch pipe, and the USACE O&M manual, 18-inch pipe. (DWR UCIP - O. Magana)

8/11/2016 Crossing was classified incorrectly. Crossing is not a gas line. This crossing appears to be an abandoned sewer line. On WS, holes are present on the pipe wall and visible cracks are found on the concrete wall where pipe crosses. According to LMA, Tim Kerr and Richard Marck, this crossing could be a City line. Need to find owner and determine fate of crossing. Owner will need to coordinate with CVFPB to comply with Title 23. (DWR UCIP - omagana)12/19/2013 No markers or labels visible to indicate line is gas line--unable to confirm. (DWR UCIP - omagana)

FIELD_STRUCT_DESC: *ABANDONED* 18-inch (not 20-inch as referenced in the DWR Levee Log) wrapped steel sewer pipe through the levee, 5 feet below the crown. The 20-inch pipe was initially referenced as a 20-inch gas line under DWR levee logs that dated back to 1956. During the 2016 inspection, the pipe was identified (field measured) as an 18-inches non-gas line. The sewer pipe has holes in it. It appears that this crossing has been mislabeled or replaced. No additional information was found. This sewer pipe is not in use and needs to be abandoned properly or removed. [Additional Reference(s): DWR Levee Log, 1956 and 2002. USACE Sacramento O&M Manual Unit 118 Part 1, August 1955, (Station 89+28)].

18-inch abandoned line and 8-inch gas line visible on WS.

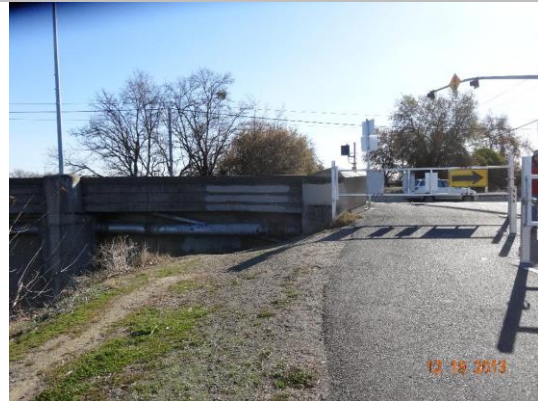
Photo 1 of 3 : UCIP_SP_2019_52685_55422.jpg

FS_ID:52685
DS_ID:24528
EP_NO: N/A
Repair Type: Non-Urgent
Crossing Status: Found
UCIP Comments: 08/29/2017 After reviewing record dsid 24492, record dsid 24492 appears to be the same record as this entry, dsid 24528. The information from dsid 24492, has been transferred to this entry. The old record will be retired from the UCIP list and considered a duplicate record. This record has been updated to reflect record source origins from both DWR Levee Logs, referenced as a 10-inch pipe, and the USACE O&M manual, 8-inch pipe. PG&E refers to this line as DFM 0613-01. (DWR UCIP - O. Magana)
08/16/2017 --previously noted under dsid 24492-- DWR Deferred Maintenance Project (DMP), Vince Rodriguez, forwarded email received from Tim Kerr, General Manager of American River Flood Control District (ARFCD) with file "DWR Eligible Pipes Found in ARFCD" from ARFCD that shows the ownership and location of the pipes Tim Kerr investigated. No owner was identified, ARFCD Staff Notes indicate listed as Not Found in UCIP - Steel Pipe on Bridge??. (DWR UCIP - O. Magana)

08/11/2017 PG&E records for DFM 0613-01 indicate that there were no observations found on the 07/2017 patrol, no leaks found on the 05/2017 leak survey, and the pipeline is operating correctly according to the 04/2017 CP inspection. ECDA in 2015; this integrity assessment identified no issues requiring corrective action. ILI in 2016; all corrective actions identified in this integrity assessment have been resolved. (DWR UCIP - A. McDonald)9/21/2016 According to CVFPB enforcement records. PG&E is working on submitting permit for gas line. (DWR UCIP - omagana)8/11/2016 gas line is clearly marked on WS. (DWR UCIP - omagana)
FIELD_STRUCT_DESC: 10-inch steel gas main through the levee, 5 feet below the crown. PG&E label found on waterside (WS) portion of exposed pipe. In case of an emergency related to this pipeline, PG&E has identified the following contacts: PG&E's local pipeline engineer, Mike Aronoff at 916-307-9472 (cell), and Gas Control (north) at 800-442-4743. For non-emergency issues, please contact the local PG&E Gas Pipeline Operations and Maintenance (GPOM) supervisors for the Sacramento region, David Wade at 209-639-1039 (cell), or Ron Hicks at 916-396-9038 (cell). [Additional Reference(s): DWR Levee Log, 2002]

Utility lines through levee and across channel.

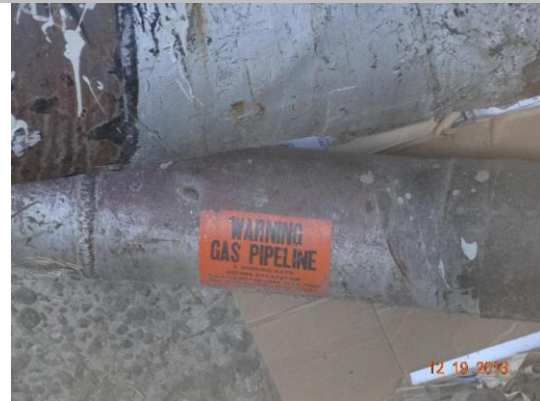
Photo 3 of 3 : UCIP_SP_2019_52685_55420.jpg

FS_ID:52685
DS_ID:24528
EP_NO: N/A
Repair Type: Non-Urgent
Crossing Status: Found
UCIP Comments: 08/29/2017 After reviewing record dsid 24492, record dsid 24492 appears to be the same record as this entry, dsid 24528. The information from dsid 24492, has been transferred to this entry. The old record will be retired from the UCIP list and considered a duplicate record. This record has been updated to reflect record source origins from both DWR Levee Logs, referenced as a 10-inch pipe, and the USACE O&M manual, 8-inch pipe. PG&E refers to this line as DFM 0613-01. (DWR UCIP - O. Magana)
08/16/2017 --previously noted under dsid 24492-- DWR Deferred Maintenance Project (DMP), Vince Rodriguez, forwarded email received from Tim Kerr, General Manager of American River Flood Control District (ARFCD) with file "DWR Eligible Pipes Found in ARFCD" from ARFCD that shows the ownership and location of the pipes Tim Kerr investigated. No owner was identified, ARFCD Staff Notes indicate listed as Not Found in UCIP - Steel Pipe on Bridge??. (DWR UCIP - O. Magana)

Label found on smaller pipe at bridge.

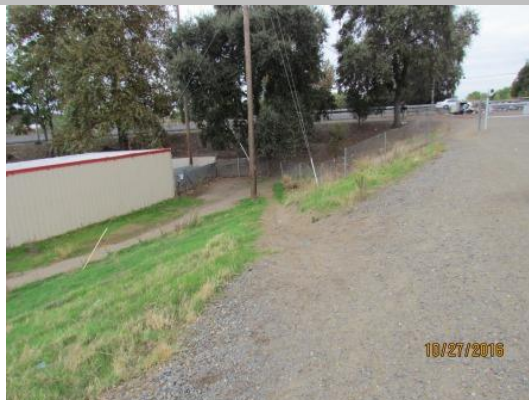
Photo 1 of 1 : SP_2019_NA0001_55_244_20190307_00194.jpg

LM Start	1.95	Rating **	A/W	Issue No.	244
LM End	1.95	Issue Type +	Ma	Location *	LS
Category	Earthen Levee			GPS Latitude/Longitude	
				Start	End
Item	Slope Stability			38.595040 °	38.595040 °
				-121.476882 °	-121.476882 °
DWR ID	DWR_NA0001_04_f_2015_244				
Comment Code					
S2 : Repair the levee slope damaged by foot traffic and prevent access where possible.					
Inspector Comment					
The erosion of the levee slope from the footpath appears to be stable at this time and should be monitored.

View of the footpath on the landside levee slope. Fall 2016

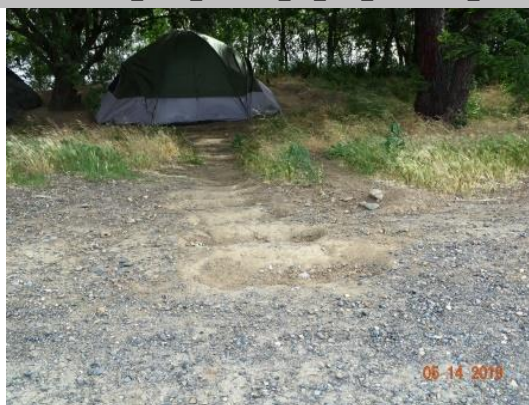
Photo 1 of 1 : SP_2019_NA0001_55_197_20190515_00274.jpg

LM Start	1.95	Rating **	U	Issue No.	197
LM End	1.95	Issue Type +	Ma	Location *	WS
Category	Earthen Levee			GPS Latitude/Longitude	
				Start	End
Item	Slope Stability			38.594958 °	38.594958 °
				-121.476800 °	-121.476800 °
DWR ID	DWR_NA0001_04_s_2019_197				
Comment Code					
S2 : Repair the levee slope damaged by foot traffic and prevent access where possible.					
Inspector Comment					
Repair slope damage from steps dug out of slope.

View looking northeast at steps that the homeless dug into the levee slope. Spring 2019

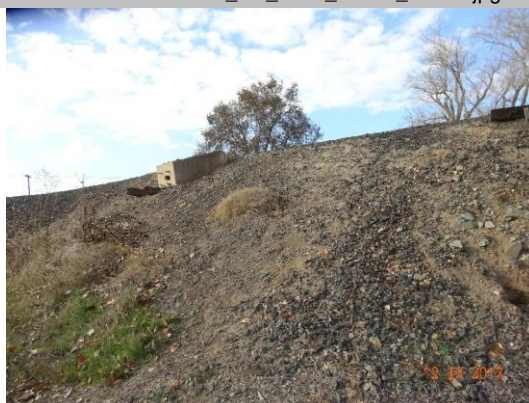
Photo 1 of 3 : UCIP_SP_2019_29927_55259.jpg

LM Start	2.25	Rating **	M	Issue No.	751
LM End	2.25	Issue Type +	En	Location *	
Category	Supplemental			GPS Latitude/Longitude	
				Start	End
Item	DWR UCIP Field Study			38.591923 °	38.591923 °
				-121.473744 °	-121.473744 °
DWR ID	24310				
Comment Code					
Inspector Comment					
FS_ID:29927 DS_ID:24310 EP_NO: 14150 Repair Type: Non-Urgent Crossing Status: Indicator Found UCIP Comments: unable to confirm if crossing is 4-inch steel conduit--will need to coordinate with owner. FIELD_STRUCT_DESC: 4-inch galvanized iron communication conduit containing fiber optic cables through the levee, 3.5 feet below the crown. Markers on the levee shoulder. Rock revetment on the waterside (WS) slope. (4-inch galvanized iron pipe authorized under Permit No. 14150, 1986-MCI Telecommunication Corp.) [Additional Reference(s): DWR Levee Log, 2002] FS Date: 12/19/2013

View of waterward slope--concrete box could be associated with conduit?

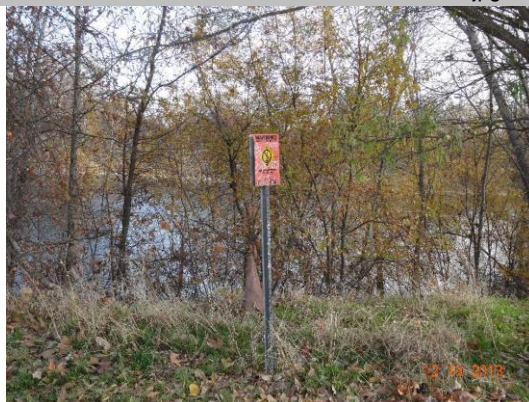
Photo 2 of 3 : UCIP_SP_2019_29927_55261.jpg

Marker for buried fiber optic cable on waterward side.

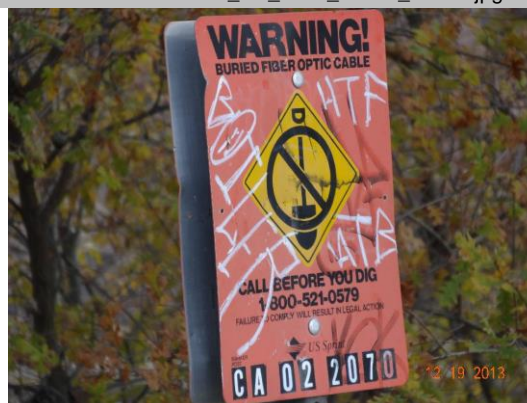
Photo 3 of 3 : UCIP_SP_2019_29927_55260.jpg

LM Start	2.25	Rating **	M	Issue No.	751 (cont)	
LM End	2.25	Issue Type +	En	Location *		
Category	Supplemental			GPS Latitude/Longitude		
				Start		End
Item	DWR UCIP Field Study			38.591923 °		38.591923 °
				-121.473744 °		-121.473744 °
DWR ID	24310					
Comment Code						
Inspector Comment						
FS_ID:29927 DS_ID:24310 EP_NO: 14150 Repair Type: Non-Urgent Crossing Status: Indicator Found UCIP Comments: unable to confirm if crossing is 4-inch steel conduit--will need to coordinate with owner. FIELD_STRUCT_DESC: 4-inch galvanized iron communication conduit containing fiber optic cables through the levee, 3.5 feet below the crown. Markers on the levee shoulder. Rock revetment on the waterside (WS) slope. (4-inch galvanized iron pipe authorized under Permit No. 14150, 1986-MCI Telecommunication Corp.) [Additional Reference(s): DWR Levee Log, 2002] FS Date: 12/19/2013

Contact information for US Sprint--not MCI as records indicate.

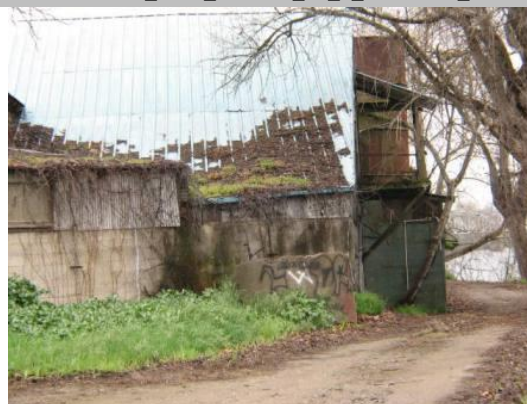
Photo 1 of 1 : SP_2019_NA0001_55_2_20190307_00002.jpg

LM Start	2.68	Rating **	U	Issue No.	2
LM End	2.68	Issue Type +	En	Location *	LS
Category	Earthen Levee			GPS Latitude/Longitude	
				Start	End
Item	Encroachments			38.588913 °	38.588913 °
				-121.467210 °	-121.467210 °
DWR ID	DWR_NA0001_04_s_2012_2				
Comment Code					
BU : Building					
Inspector Comment					
A Bell Marine structure encroaches onto the levee easement.

03/16/2012 Structure on Bell Marine property.

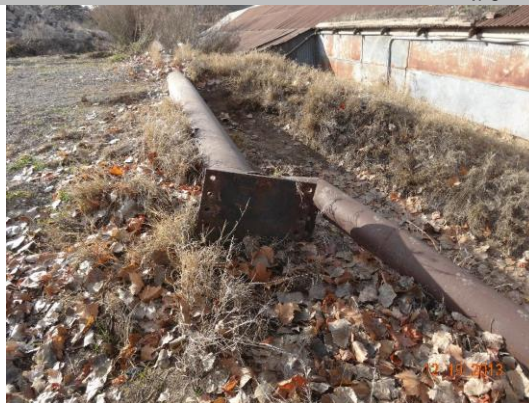
Photo 1 of 2 : UCIP_SP_2019_29944_55267.jpg

Comment Code						
Inspector Comment						
FS_ID:29944 DS_ID:24327 EP_NO: 3362 Repair Type: Non-Urgent Crossing Status: Found UCIP Comments: Pipe sections abandoned on levee crown--need to contact owner to determine status of crossing. FIELD_STRUCT_DESC: 12-inch steel water pipe through the levee at an unknown depth below the crown. Pipe extends from a settling pond, on the left bank berm, to an existing borrow pit located in the overflow area adjacent to the right bank. The pipeline is buried through the top of the riverbanks and buried in the left bank with aggregate revetment placed on the bank. The remainder of the pipeline is exposed across the bottom of the channel and the right bank. The line is used to divert wash water return from the gravel plant to the opposite side of the river. (12-inch wash water return authorized under Permit 8146, 1974-Robertson Sand and Gravel Company) FS Date: 12/19/2013

Remnants of old crossing located on levee crown.

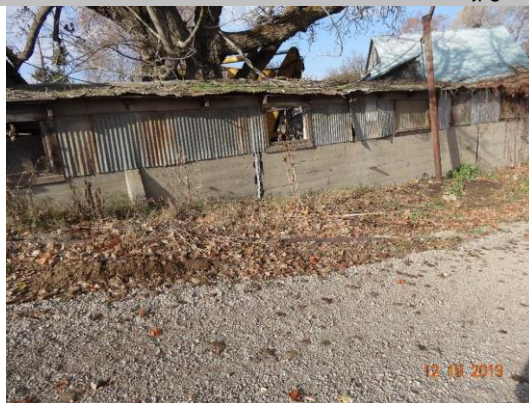
Photo 2 of 2 : UCIP_SP_2019_29944_55266.jpg

View of structure located on levee crown.

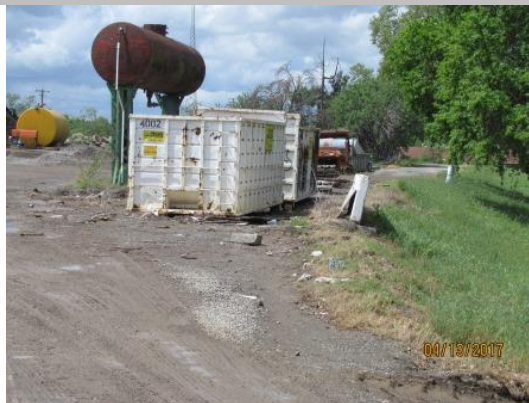
Photo 1 of 2 : SP_2019_NA0001_55_3_20190307_00003.jpg

LM Start	2.72	Rating **	U	Issue No.	3
LM End	2.86	Issue Type +	En	Location *	LS
Category	Earthen Levee			GPS Latitude/Longitude	
				Start	End
Item	Encroachments			38.587939 °	38.587299 °
				-121.466635 °	-121.464320 °
DWR ID	DWR_NA0001_04_s_2012_3				
Comment Code					
EQ : Equipment					
Inspector Comment					
The LMA sent a letter to the property owner (Bell Marine) for the violation. Equipment completely blocks the levee crown.

View of the equipment obstructing levee crown access. Spring 2017.

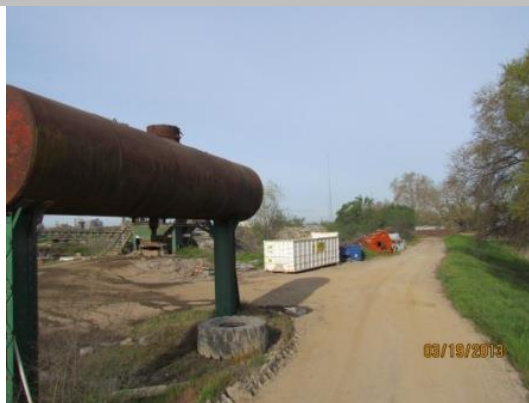
Photo 2 of 2 : SP_2019_NA0001_55_3_20190307_00004.jpg

View of the debris obstructing visibility and access.

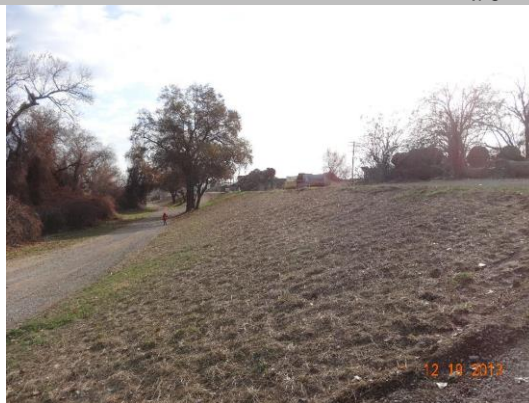
Photo 1 of 2 : UCIP_SP_2019_31444_57486.jpg

LM Start	2.77	Rating **	M	Issue No.	753
LM End	2.77	Issue Type +	En	Location *	
Category	Supplemental			GPS Latitude/Longitude	
				Start	End
Item	DWR UCIP Field Study			38.587629 °	38.587629 °
				-121.465905 °	-121.465905 °
DWR ID	24805				
Comment Code					
Inspector Comment					
FS_ID:31444					
DS_ID:24805					
EP_NO: N/A					
Repair Type: Non-Urgent					
Crossing Status: Indicator Found					
UCIP Comments: No permit (unauthorized crossing)--need additional information about crossing.					
FIELD_STRUCT_DESC: Standpipe located on waterside (WS) shoulder. Unable to confirm pipe alignment. No permit found.					
FS Date: 12/19/2013

View of waterward slope.

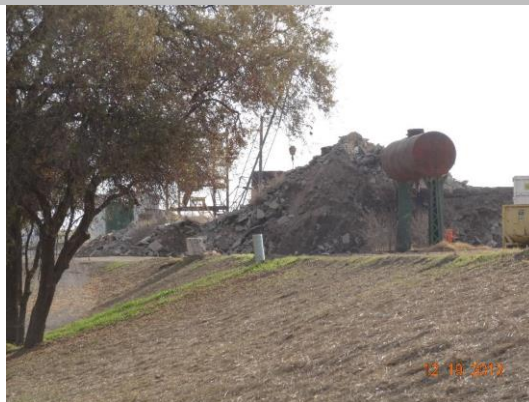
Photo 2 of 2 : UCIP_SP_2019_31444_57485.jpg

Standpipe located on waterward shoulder.

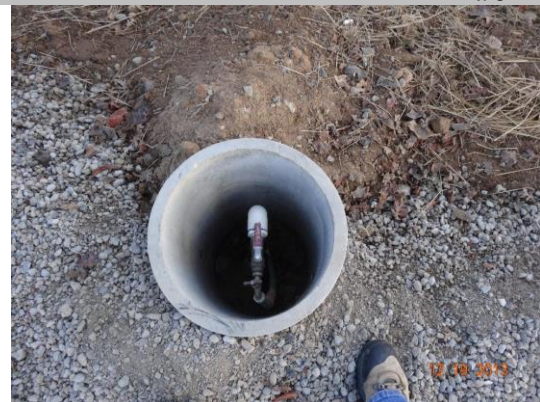
Photo 1 of 1 : UCIP_SP_2019_31445_57487.jpg

LM Start	2.82	Rating **	M	Issue No.	755	
LM End	2.82	Issue Type +	En	Location *		
Category	Supplemental			GPS Latitude/Longitude		
				Start	End	
Item	DWR UCIP Field Study			38.587438 °	38.587438 °	
				-121.464989 °	-121.464989 °	
DWR ID	24806					
Comment Code						
Inspector Comment						
FS_ID:31445						
DS_ID:24806						
EP_NO: N/A						
Repair Type: Non-Urgent						
Crossing Status: Found						
UCIP Comments: No permit found (unauthorized?)--need additional information about crossing.						
FIELD_STRUCT_DESC: Standpipe located on waterside (WS) shoulder. Pipe crosses levee crown and landside (LS). Pipe used for irrigation. No Permit found.						
FS Date: 12/13/2013

Spigot located inside riser located on waterward shoulder.

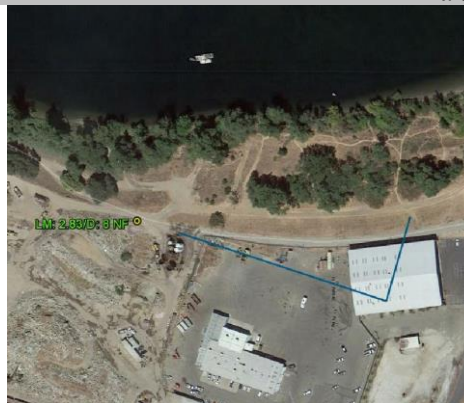
Photo 1 of 1 : UCIP_SP_2019_31253_57216.jpg

Comment Code					
Inspector Comment					
FS_ID:31253 DS_ID:24328 EP_NO: 5890 Repair Type: Non-Urgent Crossing Status: Not Found UCIP Comments: Need to contact owner to determine status of crossing--approximate alignment indicates pipe does not cross levee however records shows drain pipe crosses levee. FIELD_STRUCT_DESC: 8-inch corrugated metal drainage pipe through the levee, 2.1 feet below the crown. Concrete drop inlet structure at waterside (WS) shoulder. Maintenance facilities and yard on the landside (LS). Rock revetment on WS slope. (8-inch pipe authorized under Permit No. 5890, 1968 - City of Sacramento) [Additional Reference(s): DWR Levee Log, 2002. USACE Sacramento O&M Manual Unit 118 Part 1, August 1955, (Station 156+75)]. FS Date: 12/19/2013

Approximate alignment indicated in blue and approximate location indicated by DWR-UCIP in green label.

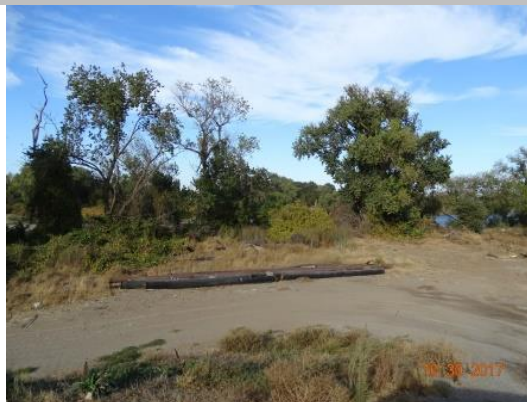
Photo 1 of 1 : SP_2019_NA0001_55_4_20190307_00005.jpg

LM Start	2.83	Rating **	M	Issue No.	4
LM End	2.83	Issue Type +	En	Location *	WS
Category	Earthen Levee			GPS Latitude/Longitude	
				Start	End
Item	Encroachments			38.587272 °	38.587272 °
				-121.464768 °	-121.464768 °
DWR ID	DWR_NA0001_04_s_2012_4				
Comment Code					
DE : Debris					
Inspector Comment					
Bell Marine staged the pipe to be moved when the water comes up.

View of the metal pipes in the floodway staged to be removed when the water rises to the top of the bank.

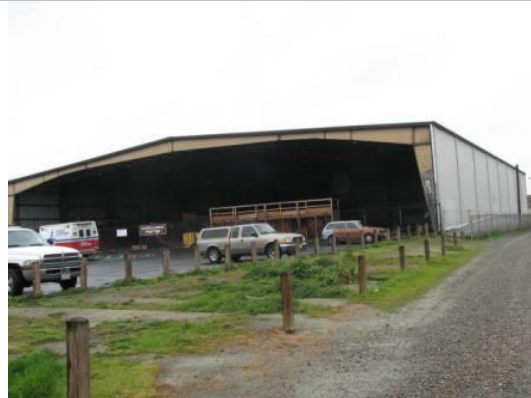
Photo 1 of 1 : SP_2019_NA0001_55_5_20190307_00006.jpg

LM Start	2.92	Rating **	U	Issue No.	5
LM End	2.96	Issue Type +	En	Location *	LS
Category	Earthen Levee			GPS Latitude/Longitude	
				Start	End
Item	Encroachments			38.587251 °	38.587318 °
				-121.463237 °	-121.462513 °
DWR ID	DWR_NA0001_04_s_2012_5				
Comment Code					
BU : Building					
Inspector Comment					
City of Sacramento building. Building is now Sutter's Landing Skate Park.

03/16/2012 Sutter's Landing Skate Park.

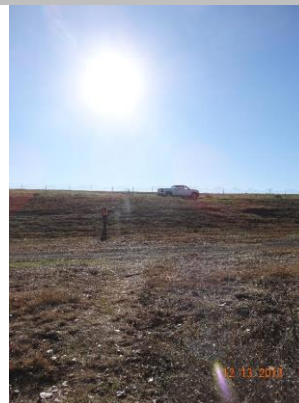
Photo 1 of 3 : UCIP_SP_2019_31254_57217.jpg

Comment Code					
Inspector Comment					
FS_ID:31254 DS_ID:24330 EP_NO: 15041 Repair Type: Non-Urgent Crossing Status: Indicator Found UCIP Comments: 08/16/2017 DWR Deferred Maintenance Project (DMP), Vince Rodriguez, forwarded email received from Tim Kerr, General Manager of American River Flood Control District (ARFCD) with file "DWR Eligible Pipes Found in ARFCD" from ARFCD that shows the ownership and location of the pipes Tim Kerr investigated. Owner of this crossing is identified as the City of Sacramento, ARFCD Staff Notes indicate landfill drain pipe (Permit# 15041) id#3424. (DWR UCIP - O. Magana) 12/13/2013 Hole present on riser located on landward side--contact owner. Additional pipe found in waterward berm. Unable to confirm if this pipe section is part of crossing--size does not match. Unable to find CM standpipe on waterward side. (DWR UCIP - O. Magana) FIELD_STRUCT_DESC: 18-inch corrugated metal drainage pipe through the levee at an unknown depth. Steel cutoff wall around pipe at center of levee. Storm drain gate on landside (LS) shoulder. Drainage ditch on LS. Corrugated metal standpipe on waterside (WS). Rock-filled ditch on WS. (18-inch pipe authorized under Permit No. 15041, 1993 - City of Sacramento) [Additional Reference(s): DWR Levee Log, 2002] FS Date: 12/13/2013

Overview of waterward side.

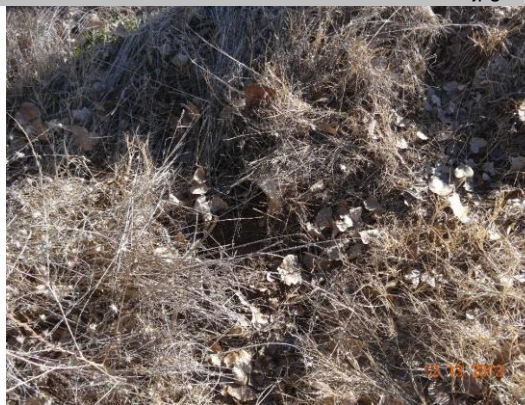
Photo 2 of 3 : UCIP_SP_2019_31254_57219.jpg

Pipe buried by vegetation--unable to determine if pipe goes through levee.

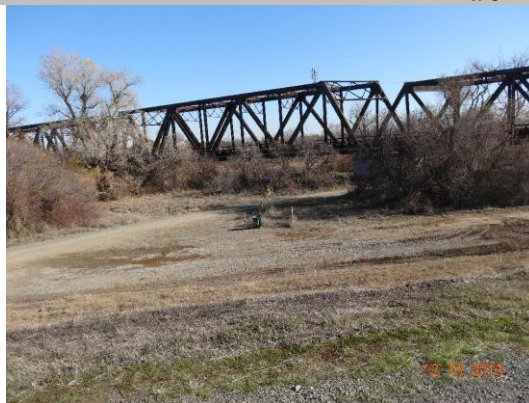
Photo 1 of 3 : UCIP_SP_2019_42128_56573.jpg

Comment Code					
Inspector Comment					
FS_ID:42128 DS_ID:24807 EP_NO: N/A Repair Type: Non-Urgent Crossing Status: Indicator Found UCIP Comments: 11/3/2014 (DWR-Olivia) Need to contact owner to determine status of crossing. Priority under Part IX has been changed from Urgent to Non-Urgent as a measure to normalize the data. Per Title 23 markers are necessary for pressure line--markers present. Recommend LMA to contact owner to determine additional information details--CVFPB permit, depth of pipe through levee, alignment, and last inspection completed confirming integrity of crossing.No permit found. Will need to contact owner to determine the status of crossing. FIELD_STRUCT_DESC: Petroleum line of unknown material or size through the levee, at an unknown depth. Markers visible on waterside (WS). Unable to confirm alignment. Markers provide Kinder Morgan (Owner) contact information - for emergencies contact 916-363-1666. FS Date: 12/13/2013

View of waterward side.

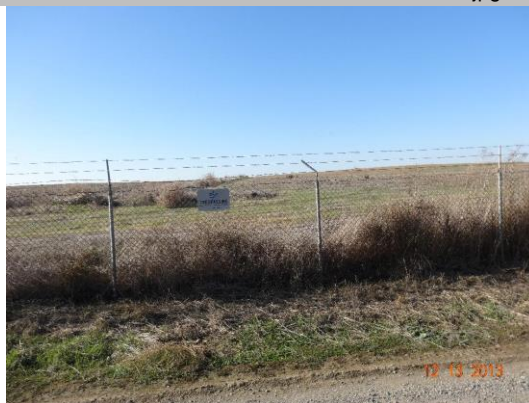
Photo 2 of 3 : UCIP_SP_2019_42128_56572.jpg

View of landward side.

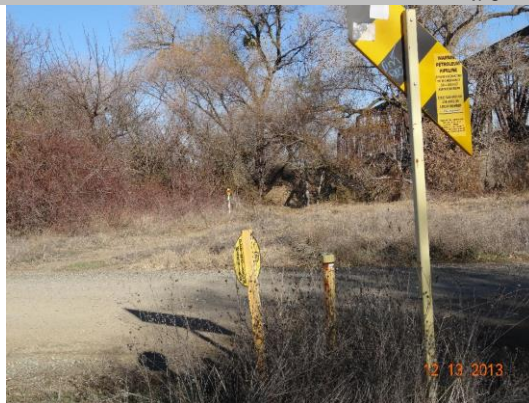
Photo 3 of 3 : UCIP_SP_2019_42128_56576.jpg

Comment Code						
Inspector Comment						
FS_ID:42128 DS_ID:24807 EP_NO: N/A Repair Type: Non-Urgent Crossing Status: Indicator Found UCIP Comments: 11/3/2014 (DWR-Olivia) Need to contact owner to determine status of crossing. Priority under Part IX has been changed from Urgent to Non-Urgent as a measure to normalize the data. Per Title 23 markers are necessary for pressure line--markers present. Recommend LMA to contact owner to determine additional information details--CVFPB permit, depth of pipe through levee, alignment, and last inspection completed confirming integrity of crossing.No permit found. Will need to contact owner to determine the status of crossing. FIELD_STRUCT_DESC: Petroleum line of unknown material or size through the levee, at an unknown depth. Markers visible on waterside (WS). Unable to confirm alignment. Markers provide Kinder Morgan (Owner) contact information - for emergencies contact 916-363-1666. FS Date: 12/13/2013

View of markers visible on landward side.

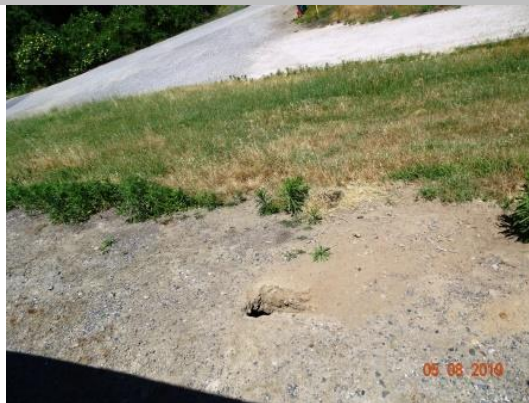
Photo 1 of 1 : SP_2019_NA0001_55_186_20190513_00265.jpg

LM Start	3.63	Rating **	M	Issue No.	186
LM End	3.63	Issue Type +	Ma	Location *	WS
Category	Earthen Levee			GPS Latitude/Longitude	
				Start	End
Item	Animal Control			38.588912 °	38.588912 °
				-121.451005 °	-121.451005 °
DWR ID	DWR_NA0001_04_s_2019_186				
Comment Code					
A3 : No rodents visible, but rodent burrows visible; need to backfill and compact or grout burrows.					
Inspector Comment					
Backfill rodent hole.

View looking downstream at animal hole on waterside slope. Spring 2019

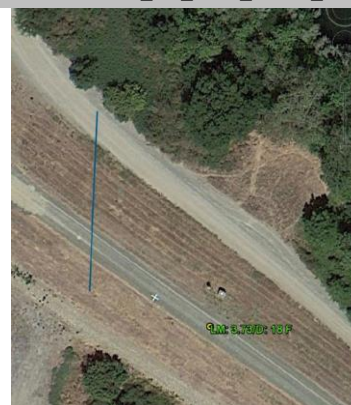
Photo 1 of 3 : UCIP_SP_2019_31255_57226.jpg

LM Start	3.75	Rating **	M	Issue No.	759
LM End	3.75	Issue Type +	En	Location *	
Category	Supplemental			GPS Latitude/Longitude	
				Start	End
Item	DWR UCIP Field Study			38.587724 °	38.587724 °
				-121.449554 °	-121.449554 °
DWR ID	24335				
Comment Code					
Inspector Comment					
FS_ID:31255 DS_ID:24335 EP_NO: N/A Repair Type: Non-Urgent Crossing Status: Found UCIP Comments: Control box is non-functional parts have been removed. Unable to confirm diameter size and status--City of Sacramento incitates a 24 inch sewer main not 18 inch. Need to contact owner to confirm size. FIELD_STRUCT_DESC: 18-inch sewer main through the levee. Concrete manhole on the waterside (WS) slope. [Additional Reference(s): DWR Levee Log, 2002] FS Date: 12/13/2013

Approximate alignment provided by City of Sacramento and DWR-UCIP confirmed location of sewer line is indicated by green label.

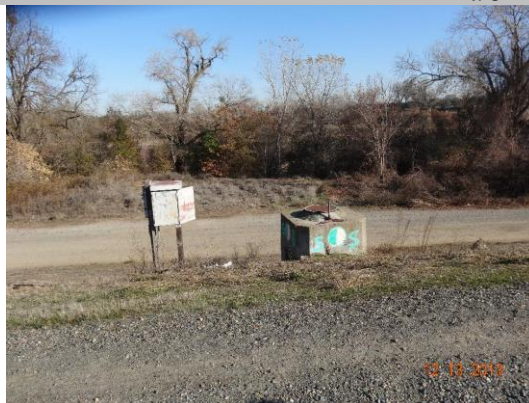
Photo 2 of 3 : UCIP_SP_2019_31255_57223.jpg

View of waterward side.

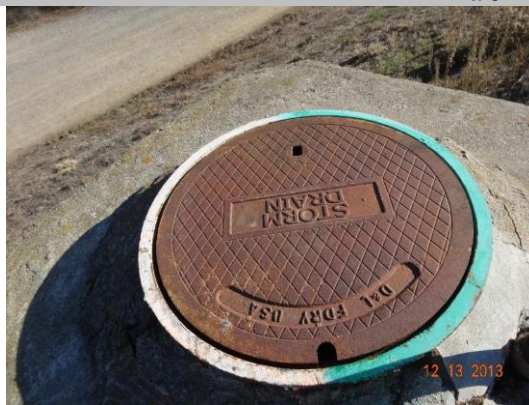
Photo 3 of 3 : UCIP_SP_2019_31255_57222.jpg

Manhole located on waterward slope.

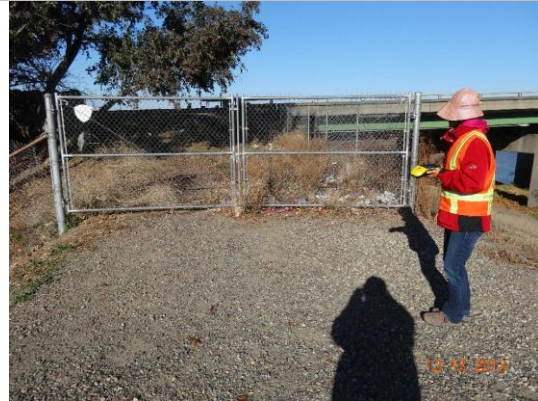
Photo 1 of 3 : UCIP_SP_2019_52708_55292.jpg

FS_ID:52708
DS_ID:24311
EP_NO: 2805
Repair Type: Non-Urgent
Crossing Status: Indicator Found
UCIP Comments: 07/18/2018 Everything appears to be the same as last time. No changes have been made. (A. McDonald - DWR UCIP)08/11/2016 Inspected the crossing with Tim Kerr and Richard Marck, LMA representatives, and it appears that this crossing is not the correct location. The odor could be due to a sewer clean out located on LS toe. Need to do additional research and coordinate with Sacramento County to confirm crossing location. (O. Magana - DWR UCIP)12/19/2016 bad odor (sewage smell) coming from this area -- potential leak. Unable to confirm if riser on landward side is part of crossing. (O. Magana - DWR UCIP)
FIELD_STRUCT_DESC: [Sacramento County Sanitation District No. 2 Pump Station] 18-inch concrete sewer main through the levee, 8 feet below the crown, 2 feet below the slopes, and approximately 50 feet from the landside (LS) edge. Concrete cutoff wall around the pipe located under the waterside (WS) shoulder. 2-inch air release valve located on the LS slope. Sewage pumping plant on LS. Manhole present. Rock revetment on the WS slope. Crossing continues under the channel and through the opposite levee. (Permit No. 2805, 1958 - Sacramento County Sanitation District No. 2). [Additional Reference(s): DWR Levee Log, 2002].

View of levee crown section near highway.

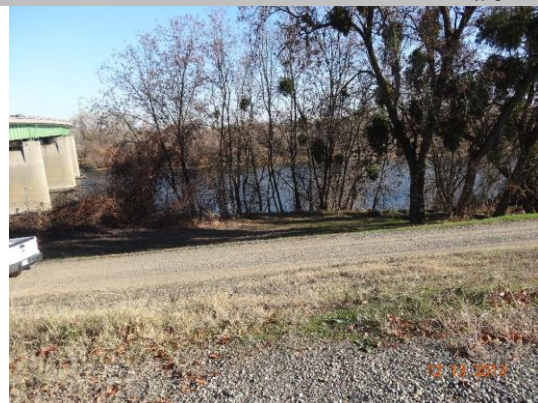
Photo 2 of 3 : UCIP_SP_2019_52708_55291.jpg

View of waterward side.

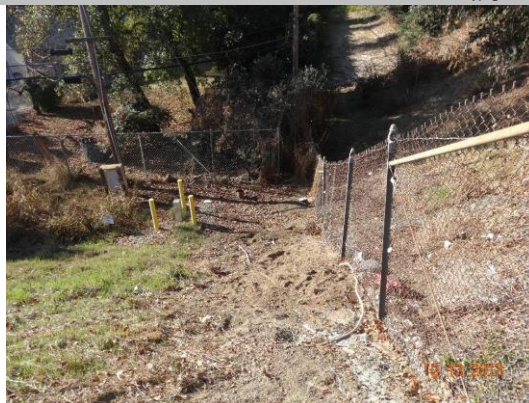
Photo 3 of 3 : UCIP_SP_2019_52708_55295.jpg

Comment Code						
Inspector Comment						
FS_ID:52708 DS_ID:24311 EP_NO: 2805 Repair Type: Non-Urgent Crossing Status: Indicator Found UCIP Comments: 07/18/2018 Everything appears to be the same as last time. No changes have been made. (A. McDonald - DWR UCIP)08/11/2016 Inspected the crossing with Tim Kerr and Richard Marck, LMA representatives, and it appears that this crossing in not the correct location. The odor could be due to a sewer clean out located on LS toe. Need to do additional research and coordinate with Sacramento County to confirm crossing location. (O. Magana - DWR UCIP)12/19/2016 bad odor (sewage smell) coming from this area -- potential leak. Unable to confirm if riser on landward side is part of crossing. (O. Magana - DWR UCIP) FIELD_STRUCT_DESC: [Sacramento County Sanitation District No. 2 Pump Station] 18-inch concrete sewer main through the levee, 8 feet below the crown, 2 feet below the slopes, and approximately 50 feet from the landside (LS) edge. Concrete cutoff wall around the pipe located under the waterside (WS) shoulder. 2-inch air release valve located on the LS slope. Sewage pumping plant on LS. Manhole present. Rock revetment on the WS slope. Crossing continues under the channel and through the opposite levee. (Permit No. 2805, 1958 - Sacramento County Sanitation District No. 2). [Additional Reference(s): DWR Levee Log, 2002]. FS Date: 8/11/2016

Sewer line along fence line on landward side--riser near back fence.

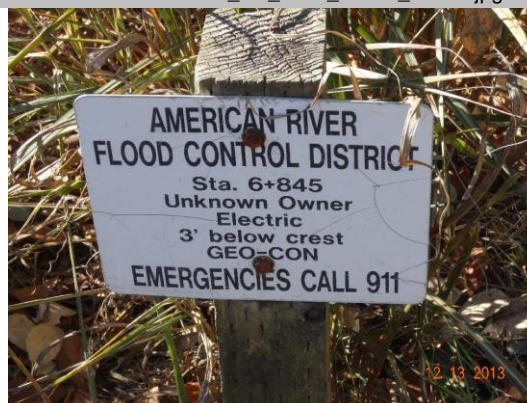
Photo 1 of 3 : UCIP_SP_2019_29054_53588.jpg

LM Start	3.89	Rating **	M	Issue No.	761
LM End	3.89	Issue Type +	En	Location *	
Category	Supplemental			GPS Latitude/Longitude	
				Start	End
Item	DWR UCIP Field Study			38.586479 °	38.586479 °
				-121.447574 °	-121.447574 °
DWR ID	24337				
Comment Code					
Inspector Comment					
FS_ID:29054 DS_ID:24337 EP_NO: N/A Repair Type: Non-Urgent Crossing Status: Found UCIP Comments: Unknown owner--Need to coordinate with DWR Inspector and CVFPB. FIELD_STRUCT_DESC: 3-inch communication polyvinyl chloride (PVC) conduit through levee, 2 feet below the crown. [Additional Reference(s): DWR Levee Log, 2002] FS Date: 12/13/2013

Electrical conduit marker located on landward toe.

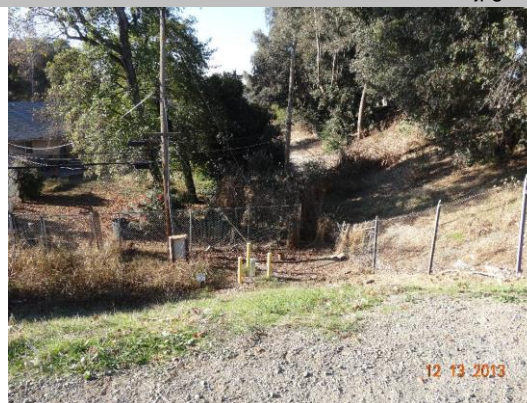
Photo 2 of 3 : UCIP_SP_2019_29054_53587.jpg

View of landward side.
